Illinois Commerce Commission  
Assessment of Central Illinois Light Company's  
Reliability Report for the 2000 Period

Pursuant to 83 Ill. Adm. Code 411.140

**December 12, 2001**

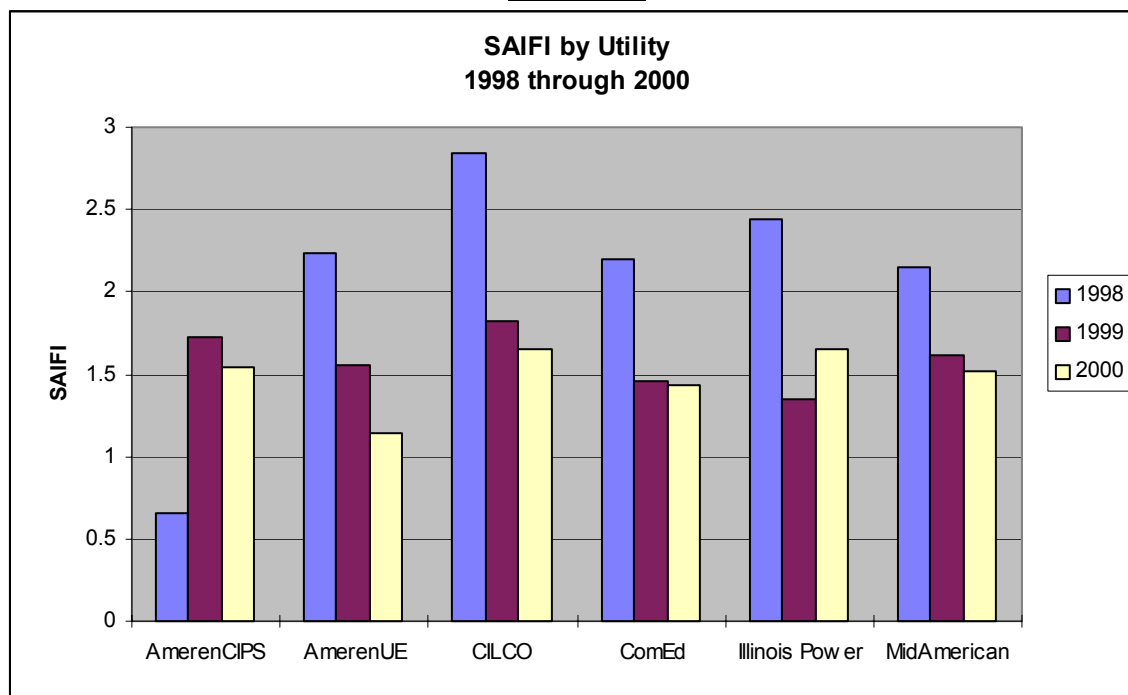
**Figure 14**

Figure 14 below shows a comparison of SAIFI values reported by the Illinois utilities for years 1998, 1999, and 2000. Storms throughout the state in 1998 increased all utilities' SAIFI numbers. CILCO's reported 2000 reliability performance did not change greatly from 1999. While there is an apparent trend of SAIFI improvement from 1998 through 2000, CILCO still has the highest SAIFI (tied with Illinois Power) compared to the other utilities.

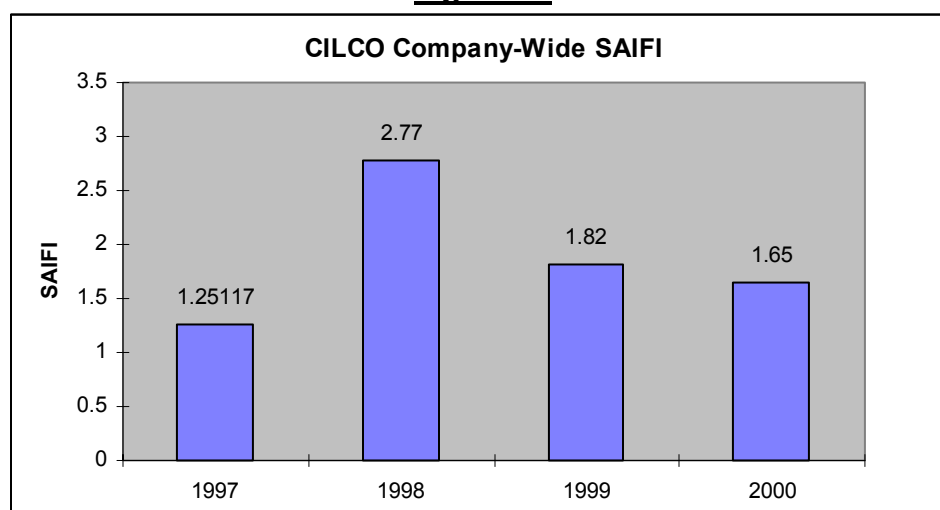
**Figure 15**

Figure 15 below shows CILCO's SAIFI indices over the past four years. CILCO's reported SAIFI for 2000 indicates a moderate improvement from 1999 in the frequency of interruptions, and the overall trend shows improvement since 1998. Keeping in mind the changes in CILCO's outage reporting system discussed earlier in this report, however, it is unclear to what degree this represents improvement in the actual electric system reliability.

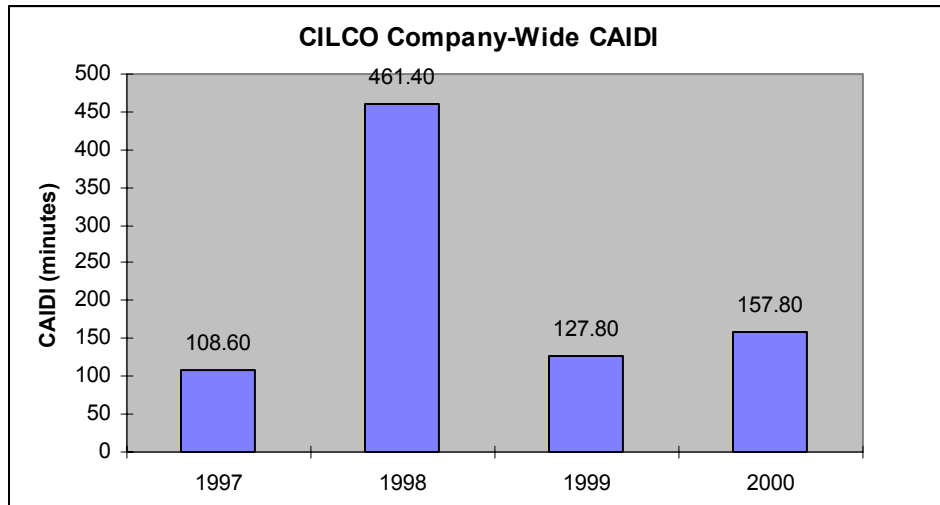
**Figure 16**

Figure 16 below shows CILCO's system wide CAIDI statistics over the past four years. While there is not a definite, clear trend of these values for CILCO, the 2000 CAIDI index is 23% worse than the one for 1999. Except for 1998, when an unusual number of storms hit all Illinois utilities, the CAIDI trend for CILCO seems to be generally upward.

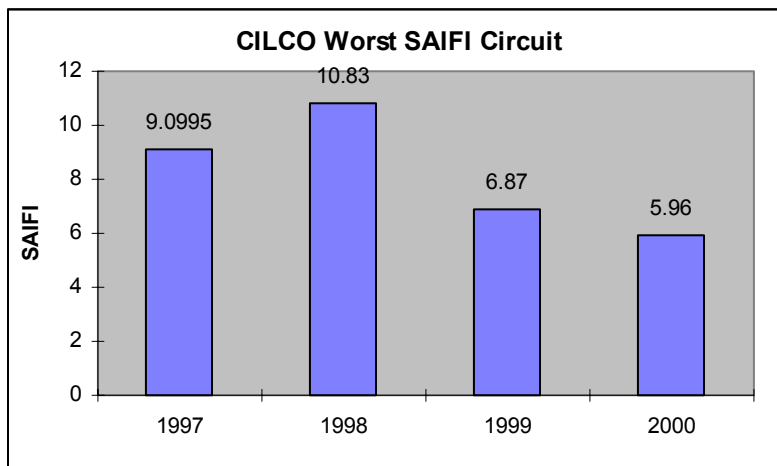
**Figure 17**

Figure 17 below shows the SAIFI index of CILCO's single worst performing circuit as reported over each of the last four years. For this statistic, the trend is downward (improving) since 1998.

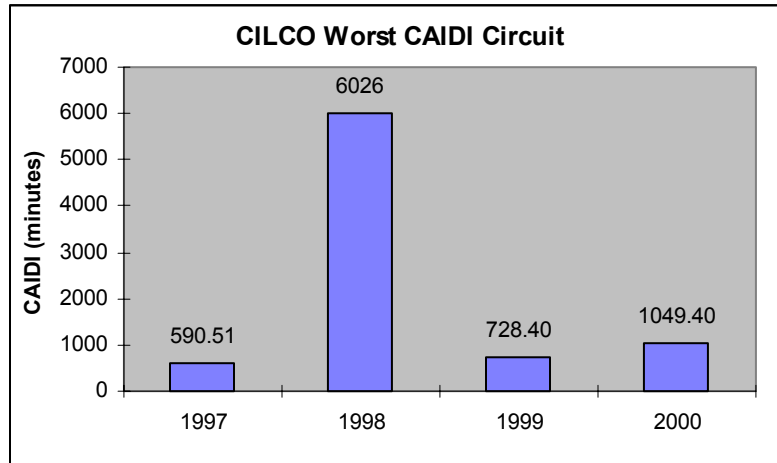
**Figure 18**

Figure 18 below shows the CAIDI index of CILCO's single worst performing circuit as reported over each of the last four years. Like the company-wide CAIDI index discussed earlier, the trend for CILCO's worst-circuit CAIDI is also generally upward.
